Elizabeth Tomsik

Materials & Processes (M&P) Engineering Internship Projects

LETF ICPSU Test Ground Plate Failure Investigation

R-12 Paul Recharger High Pressure Liquid Oxygen Poppet Failure Investigation

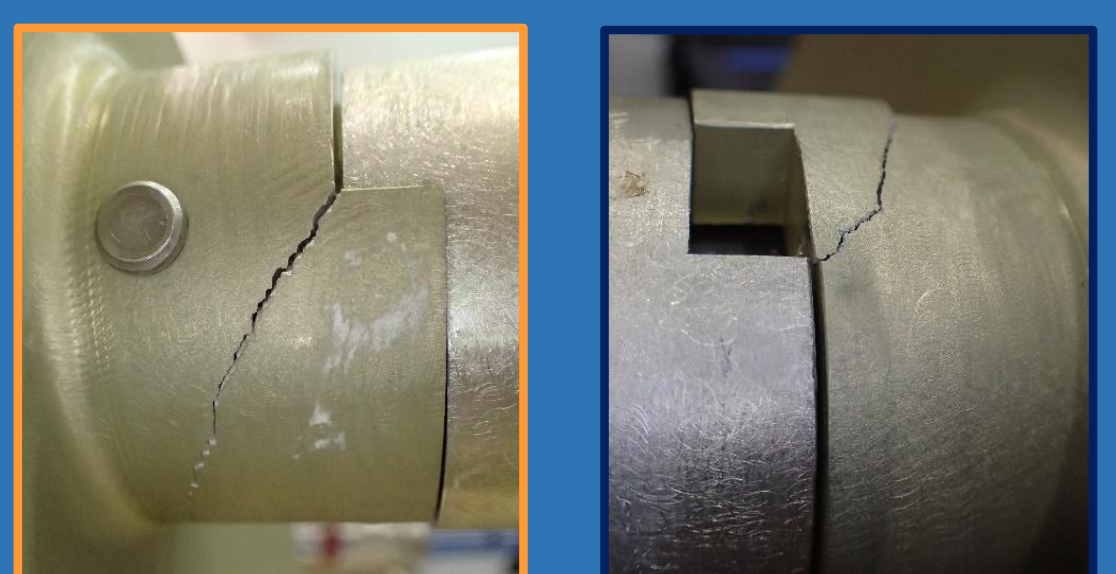
On-site photo of both failed ground plates before they were removed from original configuration

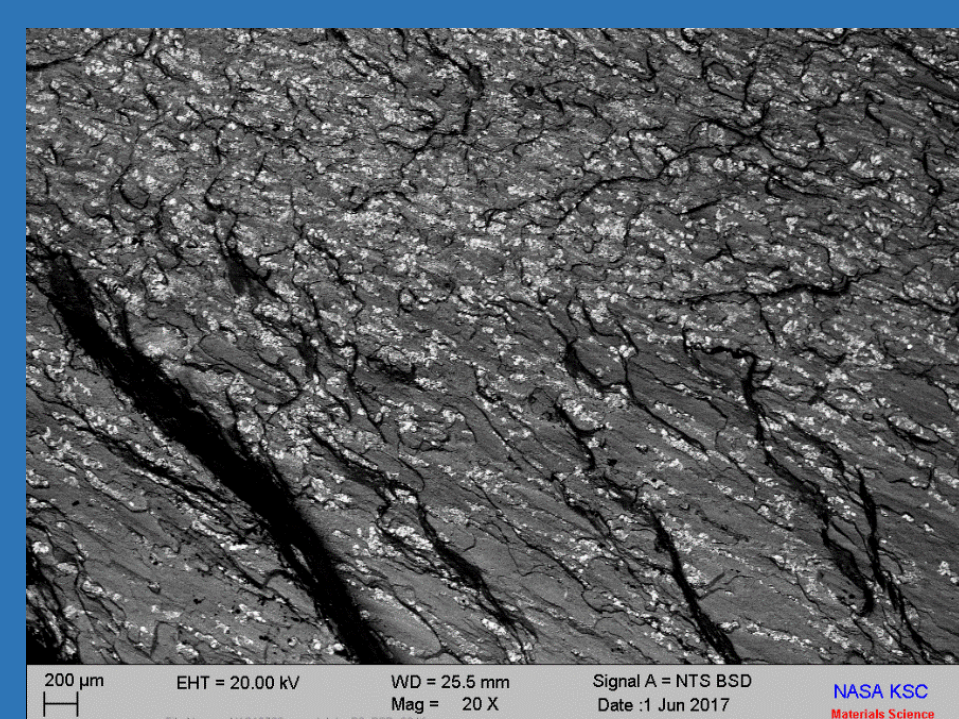
Scanning Electron Microscope (SEM) Back Scatter Detector (BSD) image highlighting precipitates

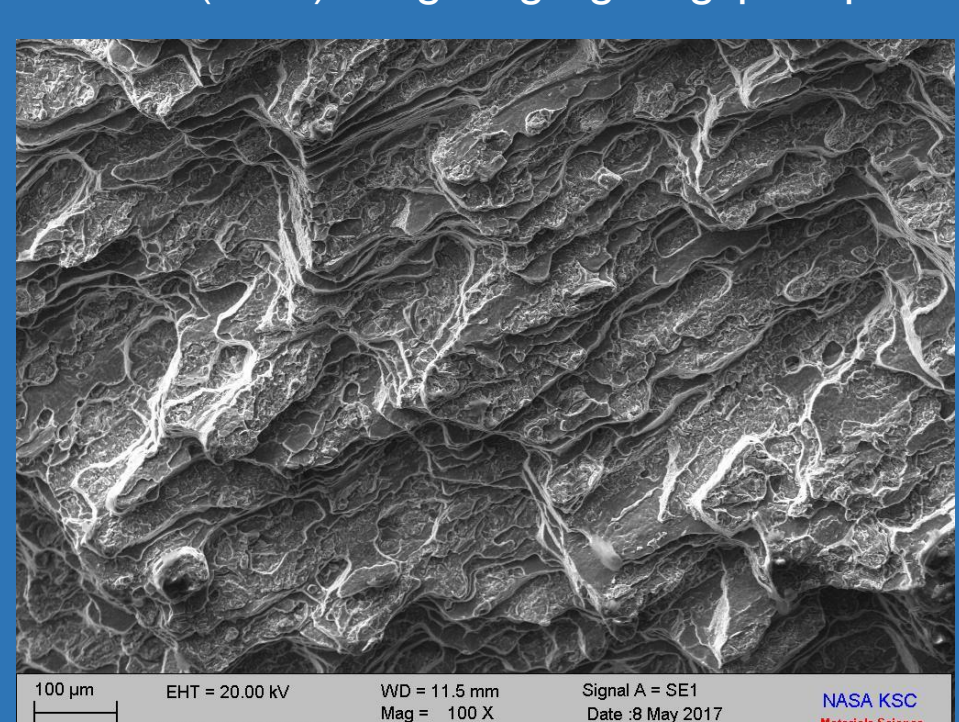
SEM Secondary Electron (SE) image showing fracture feature topography

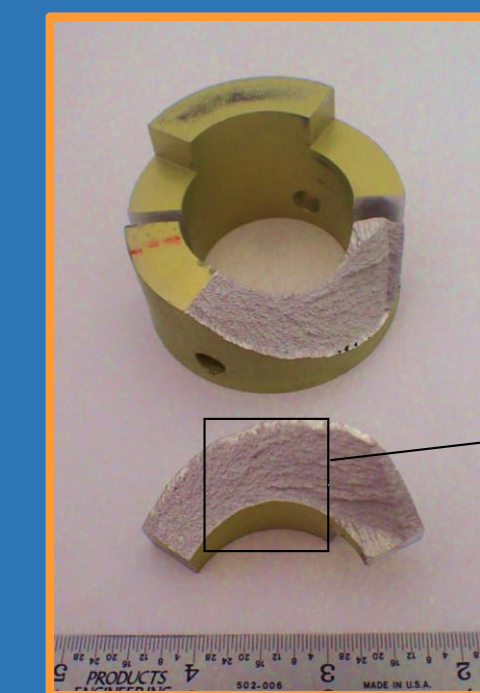
Photo of left ground plate after crack was opened

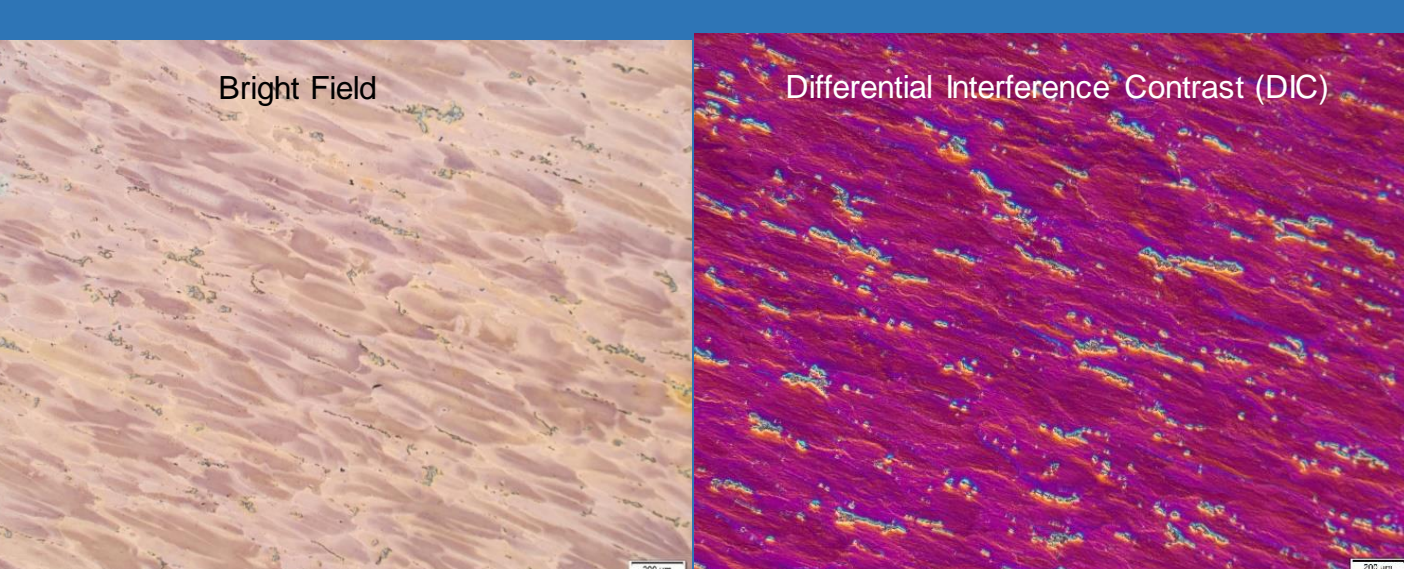
Inverted Metallograph images at 50X magnification showing microstructure of transverse cross-section after etching

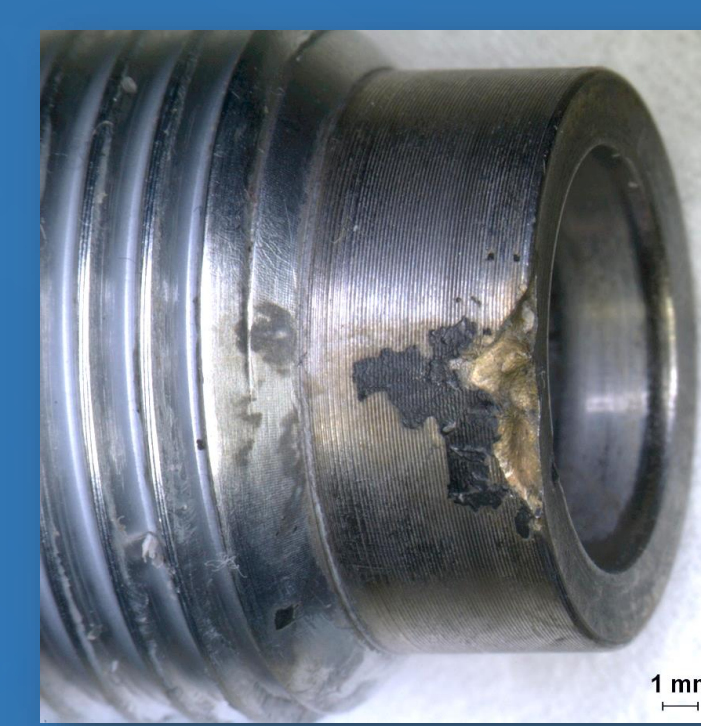
Damaged area of 17-4 PH Stainless Steel Discharge Fitting at 6.3 X magnification

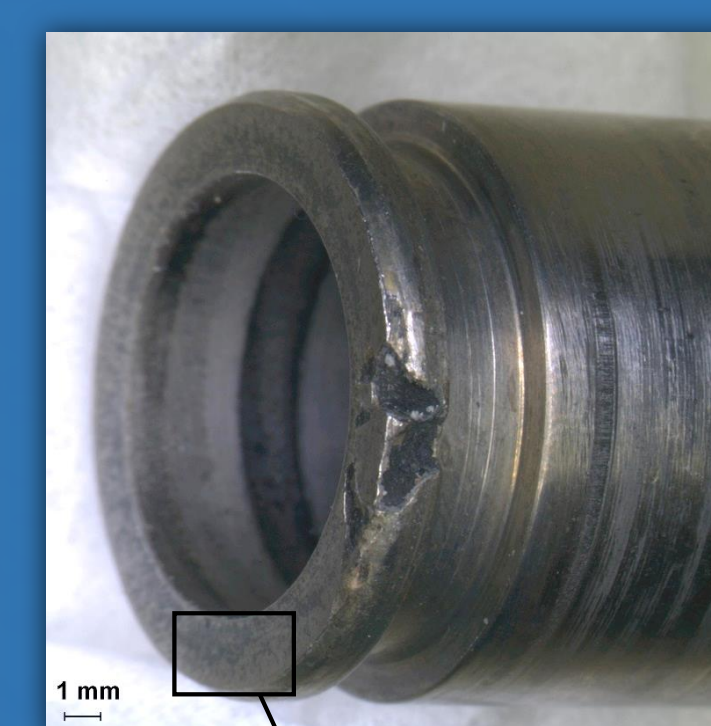
Damaged area of Monel K-500 Poppet at 6.3X magnification

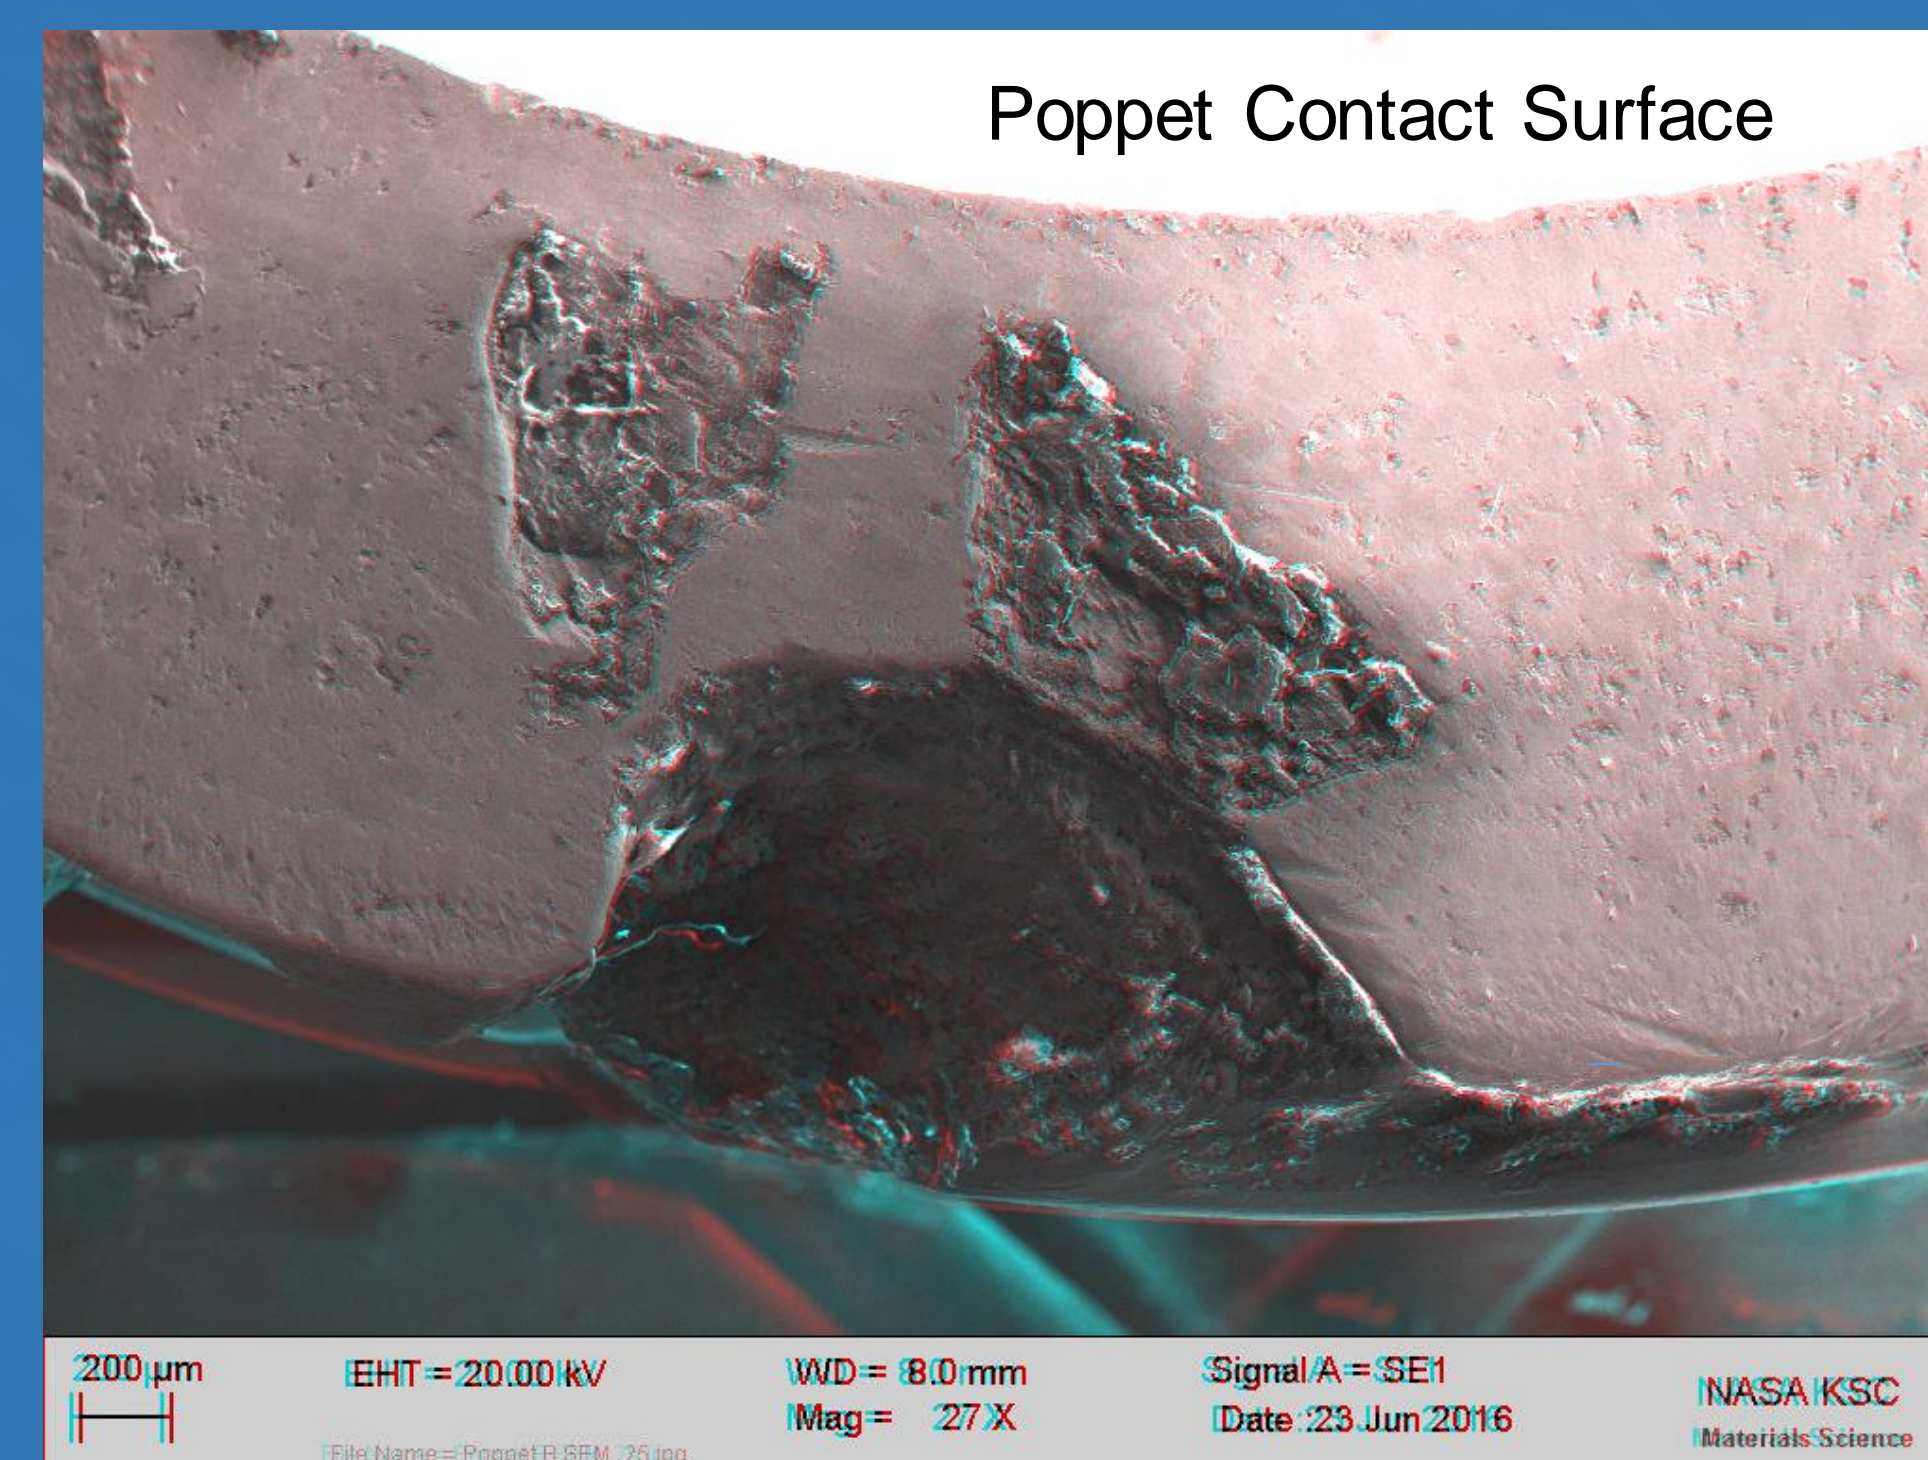
3D SEM image showing severe Fretting Corrosion/Wear effects

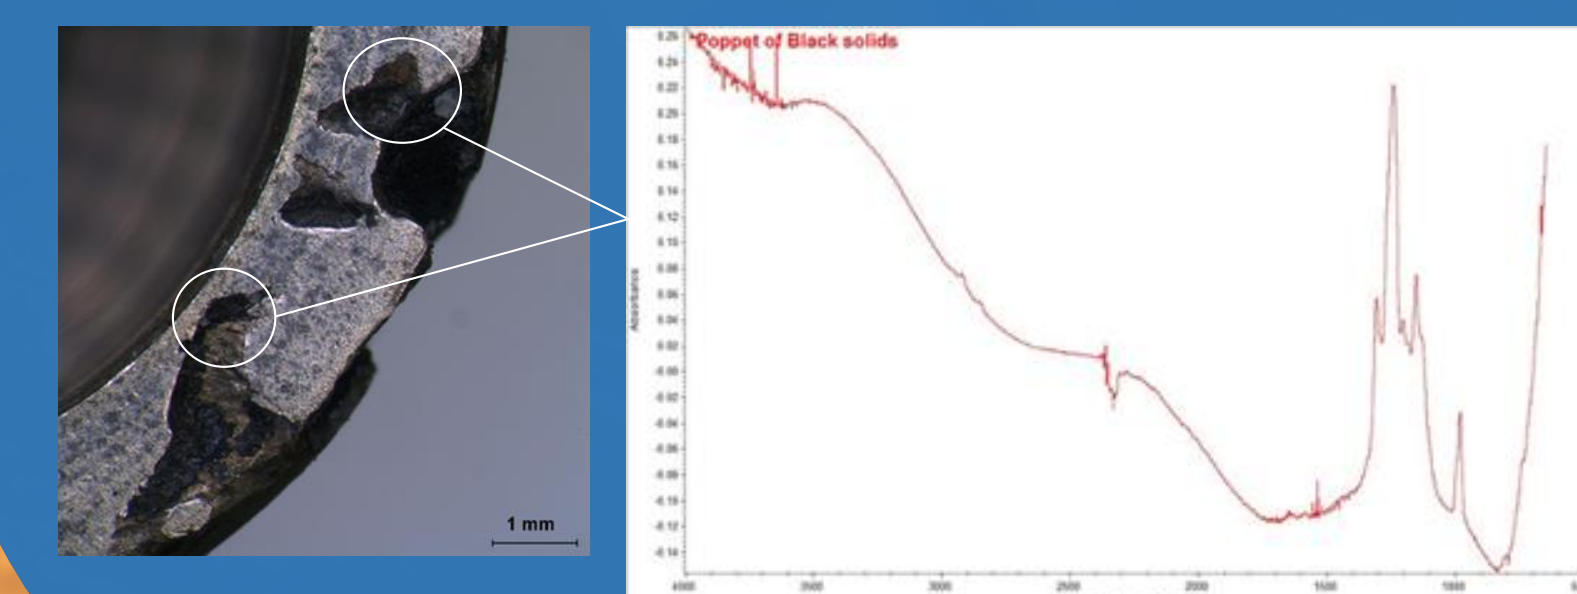
Fourier Transform Infrared Spectroscopy results showing that residue found in pits is composed of metal oxides and fluorinated grease

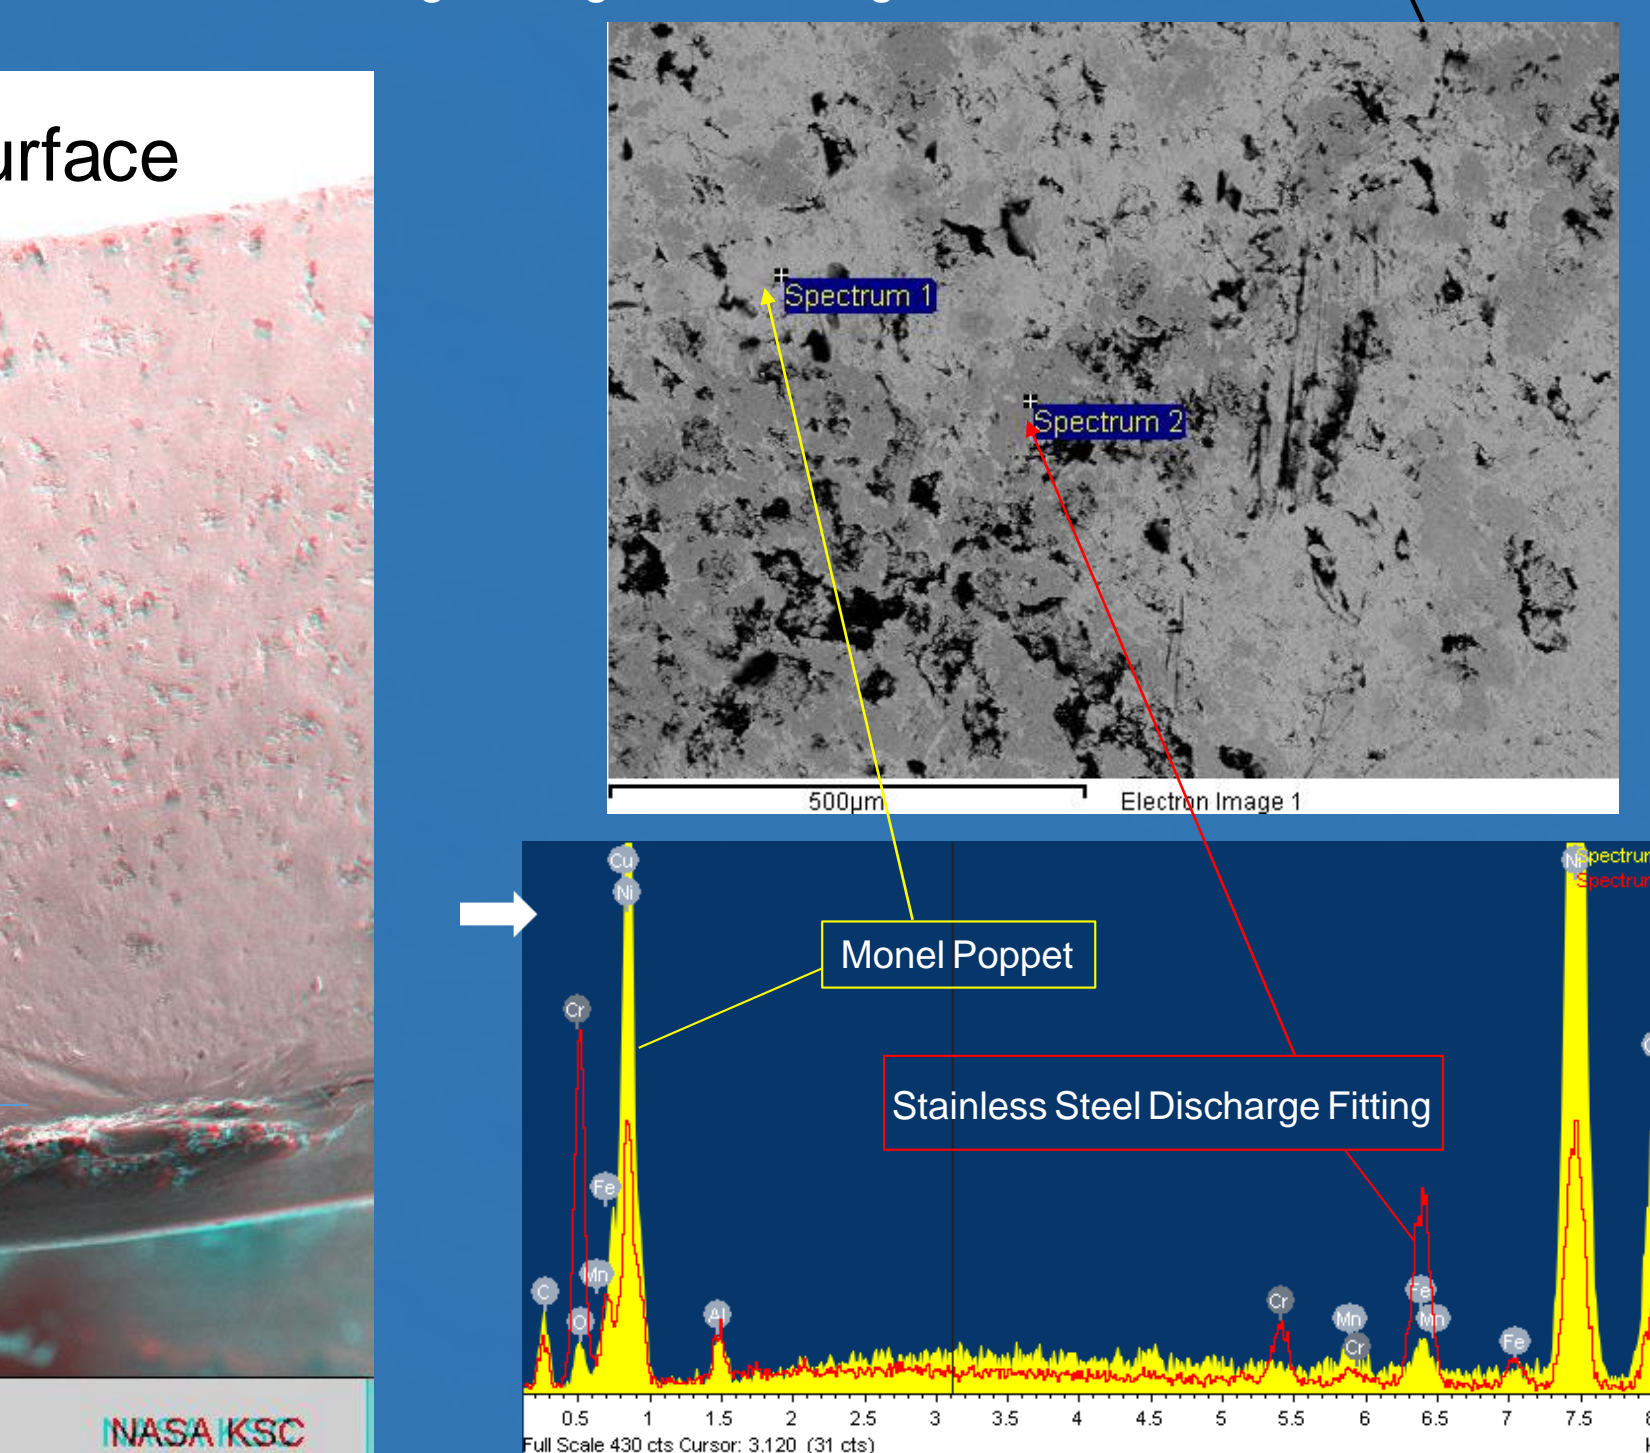
SEM BSD image and Energy Dispersive Spectroscopy (EDS) graph indicating material transfer between the Stainless Steel Discharge Fitting and the Monel Poppet contact surfaces

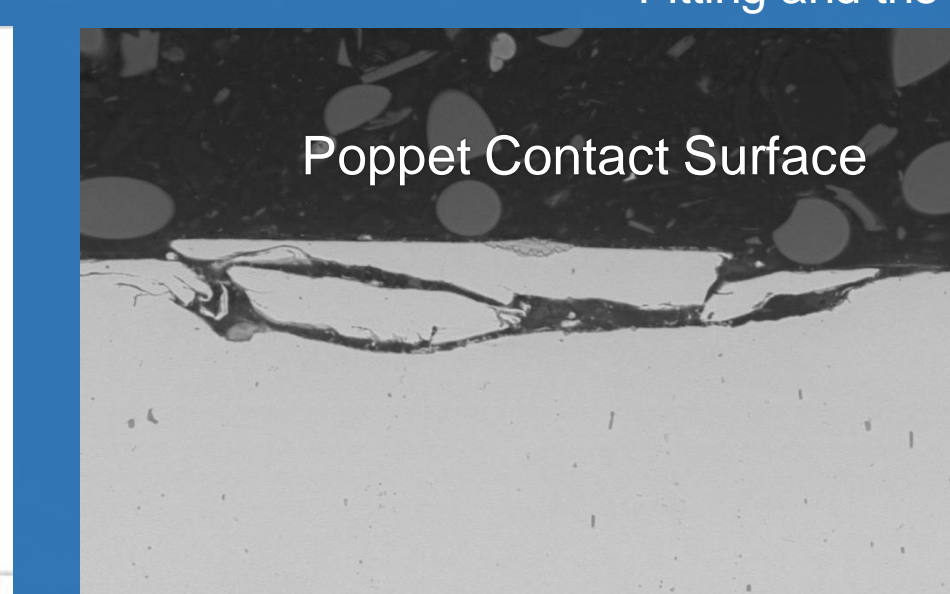
SEM image of Poppet's cross-sections showing evidence of spalling

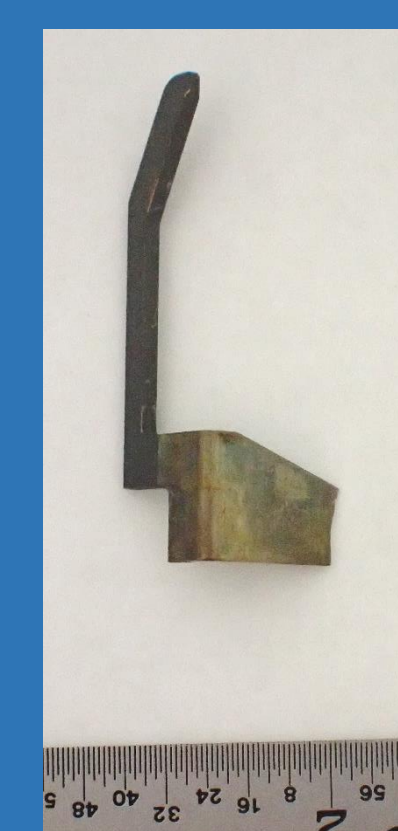
Photo of broken locking spring blade as received in laboratory

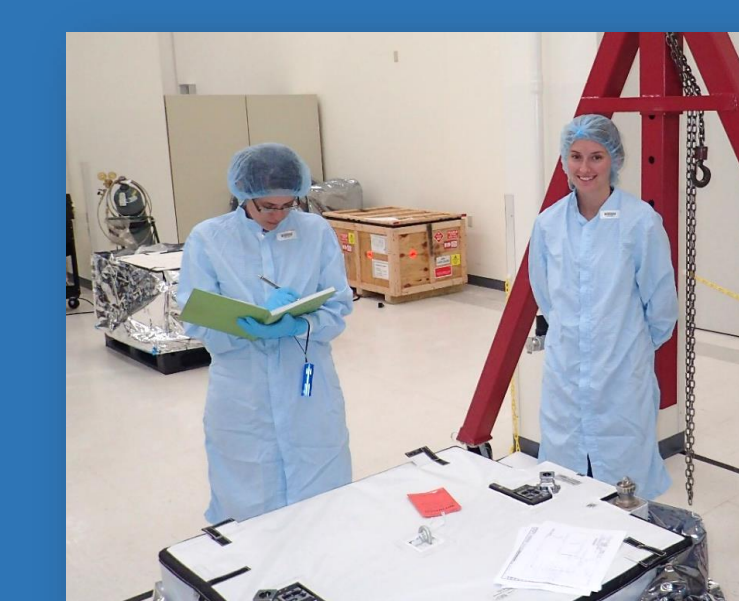
On-site photo of micro square lock where broken spring blade was configured

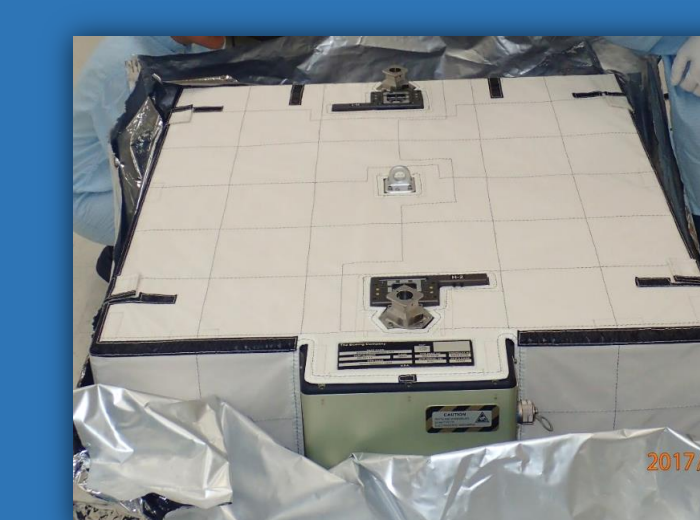
On-site photo taken of the Lithium Ion battery with the broken spring blade

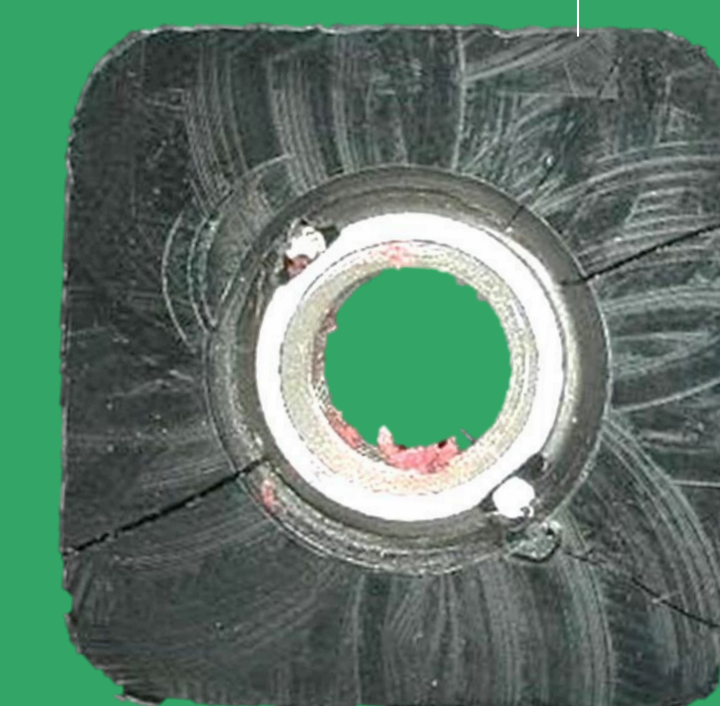
Keyence Digital Microscope image at 100X showing cracks
